Flood Control Project Maintenance
2013 Structure Summary Report
Overall Unit and Item Ratings

Black Rascal Creek Drop Structure

Flood Control Project Maintenance**Unit Cover Sheet****2013 Structure Inspection Results****Merced Streams Group**

Structure
Owens Creek Siphon Structure

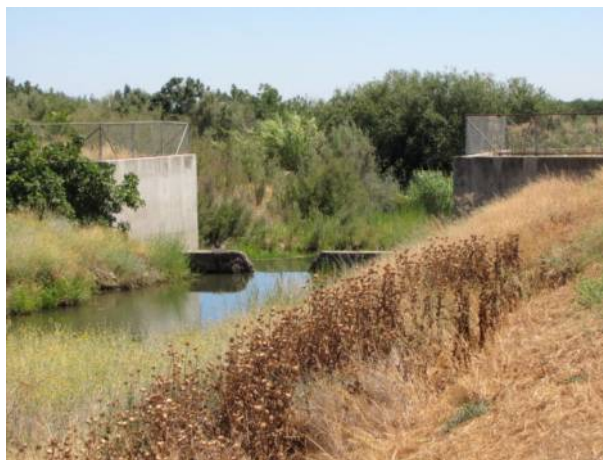
Levee Mile Report Line	1
Start Levee Mile	0.00
End Levee Mile	0.00
Location	
Category	Structures
Item	Photo Documentation

Black Rascal Creek Drop Structure view from Unit 1 Right bank. Photo taken 7-16-2013.

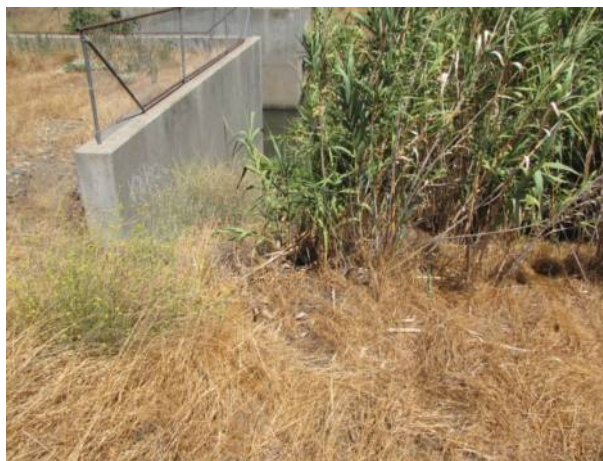
Levee Mile Report Line	2
Start Levee Mile	0.00
End Levee Mile	0.00
Location	
Category	Structures
Item	Vegetation & Obstructions

LMR No.	Levee Mile		Category	Item	Location	Rating	Action/Comment	GPS Latitude/Longitude		Issue No.
	Start	End						Start	End	Photo
1	0.00	0.00	Structures	Photo Documentation		N		37.314750 ° -120.396397 °	37.314750 ° -120.396294 °	1 Y
2	0.00	0.00	Structures	Vegetation & Obstructions		M	Inspector Comments: The vegetation growing around the structure need to be maintained. To date July 10th 2012. Veg (bambo) growing on downstream side of structure right bank.	37.314750 ° -120.396294 °	37.314750 ° -120.396294 °	2 Y
3	0.00	0.00	Structures	Shoaling / Sedimentation		A	Inspector Comments: No shoaling or sedimentation present.	37.314750 ° -120.396294 °	37.314750 ° -120.396294 °	3
4	0.00	0.00	Structures	Erosion / Bank Caving		M	Inspector Comments: There is erosion on unit 1 at the downstream end of structure along the slope caused by pedestrians. There is also erosion on the bank of unit 2 downstream of structure. Repairs are needed.	37.314620 ° -120.396294 °	37.314620 ° -120.396270 °	4 Y

Right bank downstream of Black Rascal Drop Structure wild bamboo present on right bank downstream. Photo taken 7-16-2013.

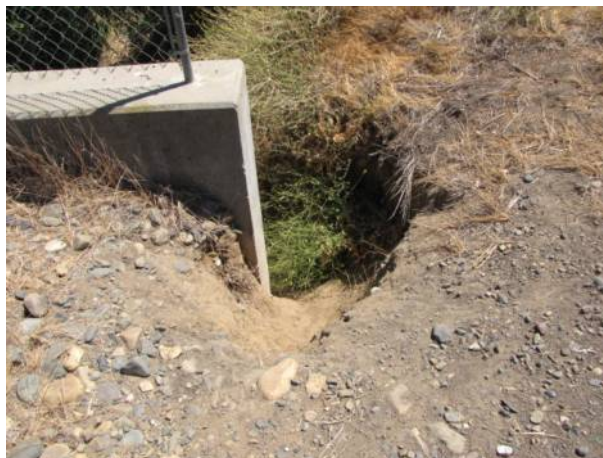
Levee Mile Report Line	4
Start Levee Mile	0.00
End Levee Mile	0.00
Location	
Category	Structures
Item	Erosion / Bank Caving

Foot erosion remains from last inspection. Photo taken 7-16-2013.

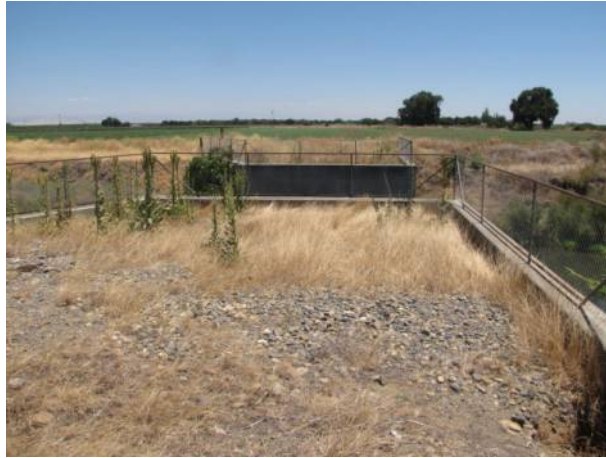
Levee Mile Report Line	23
Start Levee Mile	0.00
End Levee Mile	0.00
Location	
Category	Structures
Item	Safety

This photo shows both sides right bank and left bank security fences are good, no defects. Photo taken 7-10-2012.

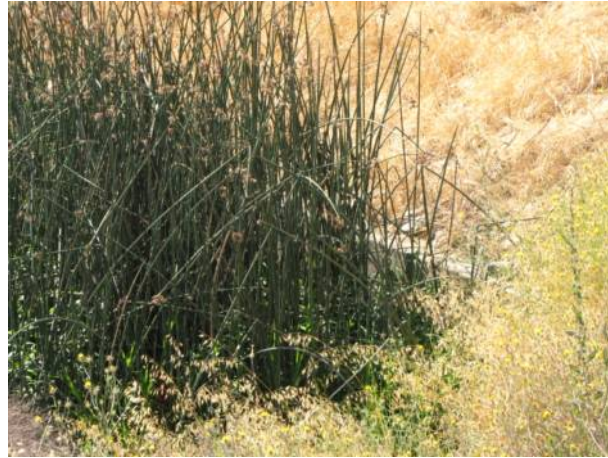
Levee Mile Report Line	1
Start Levee Mile	0.00
End Levee Mile	0.00
Location	
Category	Structures
Item	Photo Documentation
Owens Creek Siphon Outlet. Photo taken 7-16-2013.	
phillips_t_20130821_027.JPG

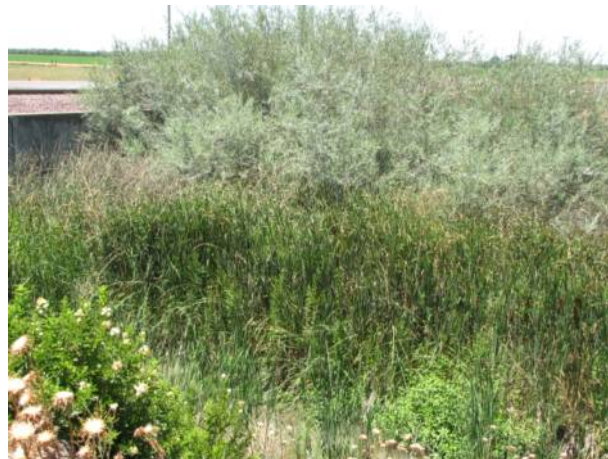
Levee Mile Report Line	2
Start Levee Mile	0.00
End Levee Mile	0.00
Location	
Category	Structures
Item	Vegetation & Obstructions
Wild growth of willow trees and tullies choking off inlet side on structure. Remove the wild growth. Photo taken 7-10-2012.	
phillips_t_20130618_015.jpg

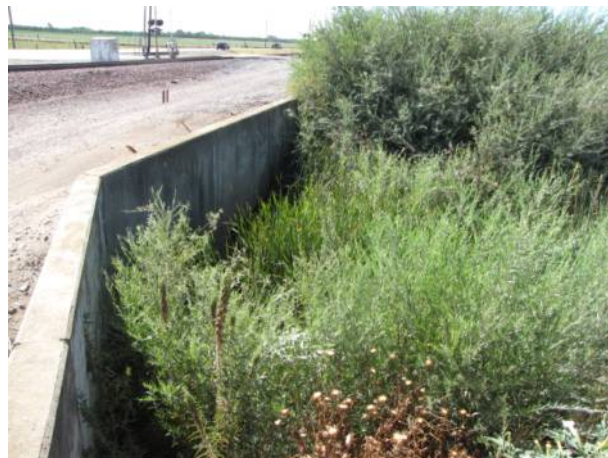
Levee Mile Report Line	7
Start Levee Mile	0.00
End Levee Mile	0.00
Location	
Category	Structures
Item	Culverts: Inlets / Outlets
The Inlet is blocked with wild growth that need to be removed. Photo taken 7-16-2013.	
phillips_t_20130821_028.JPG
